# Manhole Inspection Summary

Manhole # S29EE\_016MH

Insp Date: **4/22/09 3:09 PM**

**Location** Address: **STODDARD ST**

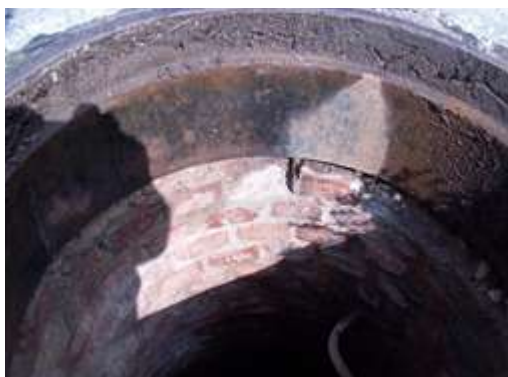
Defect 1

Condition: ☐ Sound ☐ Cracked ☐ Root Intrusion ☒ **Loose Brick** ☐ Deteriorated

CHIMNEY LOOSE BRICKS

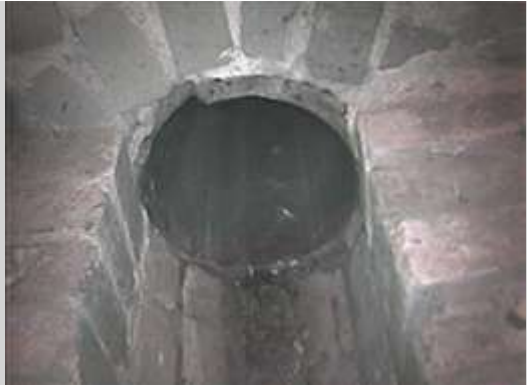
12 O'Clock Outflow

8 in. Circular Gravity Sewer  
Pipe Out @ 12 O'Clock

Infiltration: **None** Pipe Seal Cond: **Broken**

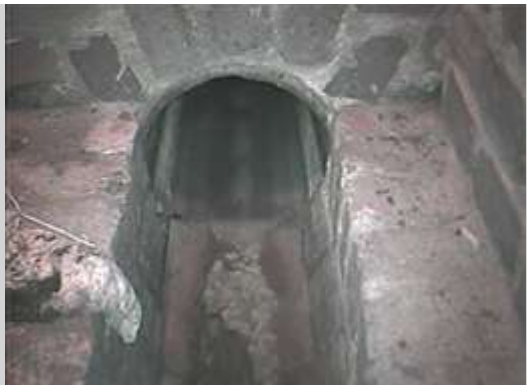
6 O'Clock Inflow

8 in. Circular Gravity Sewer  
Pipe In @ 6 O'Clock
